Photographs 2012-2017

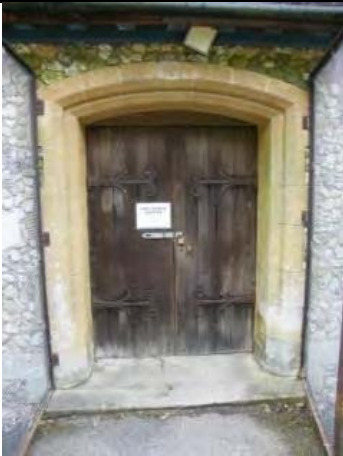
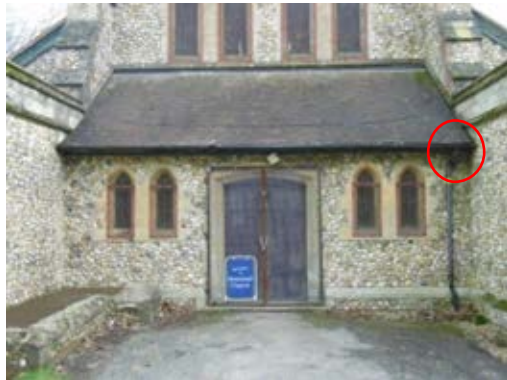
| | 2012 | 2014 | 2017 |
|---|---|---|--|
| 3. | | | |

| | 2012 | 2014 | 2017 |
|---|---|---|--|
| | Main entrance - typical condition of all doors | | Front Entrance – Defective gutter outlet to rainwater downpipe on right. |

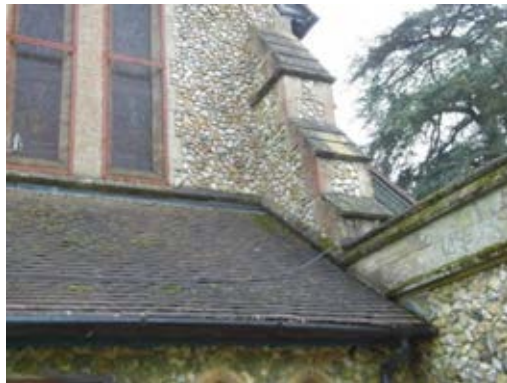
| | 2012 | 2014 | 2017 |
|---|---|---|--|
| 4. | | | |

| | 2012 | 2014 | 2017 |
|---|---|---|--|
| | | | General view of entrance roof and buttress. |

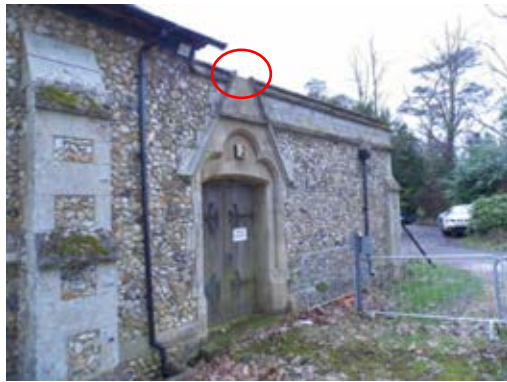
| | 2012 | 2014 | 2017 |
|---|---|--|--|
| 6. | | | |

| | 2012 | 2014 | 2017 |
|---|---|--|--|
| | | | Front Left missing key stone above e door. |

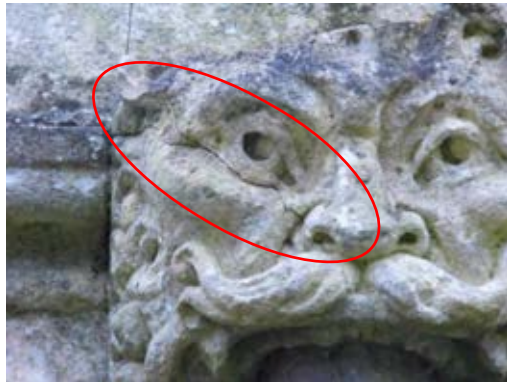
| | 2012 | 2014 | 2017 |
|---|--|---|--|
| 9. | | | |

| | 2012 | 2014 | 2017 |
|---|--|---|--|
| | | | Crack to front left stone feature. |

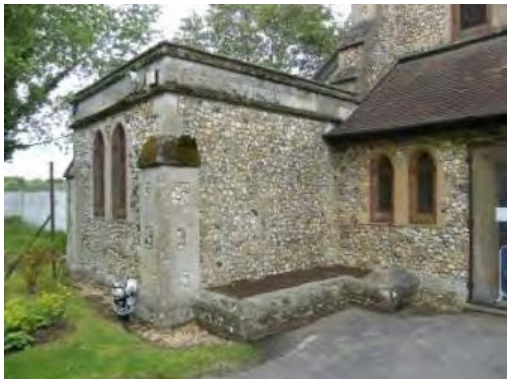
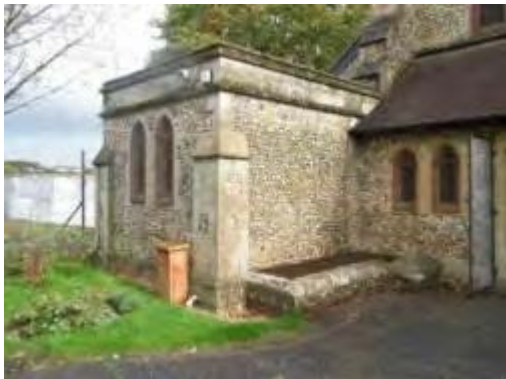
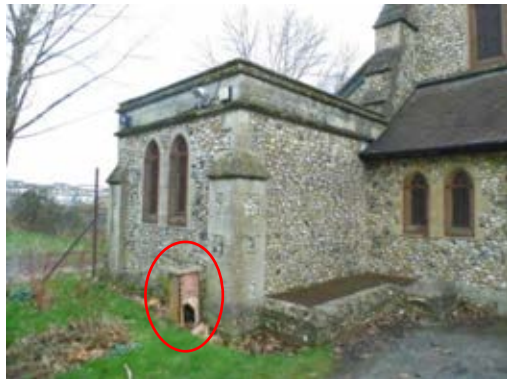
| | 2012 | 2014 | 2017 |
|---|--|---|--|
| 10. | | | |

| | 2012 | 2014 | 2017 |
|---|--|---|--|
| | Front left and external basement access. | Front left and basement access. Boxed in communal heating pipework. | Front left and basement access. Damage to communal heating pipework boxing. |

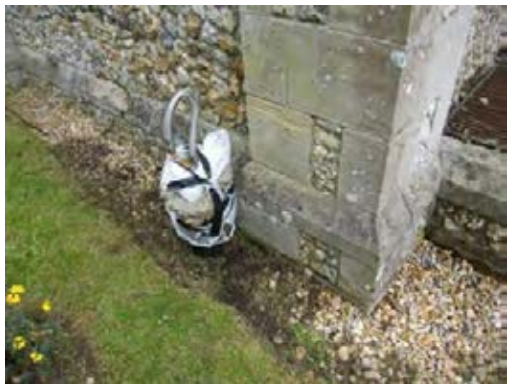
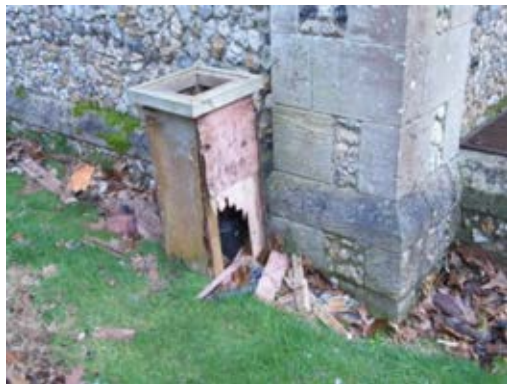
| | 2012 | 2014 | 2017 |
|---|---|---|--|
| 11. | | | |

| | 2012 | 2014 | 2017 |
|---|---|---|--|
| | Communal heating & hot water system outlet to front left room. | | Damage to communal heating pipework boxing. |

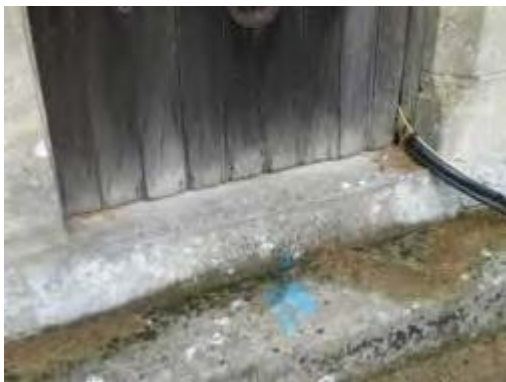
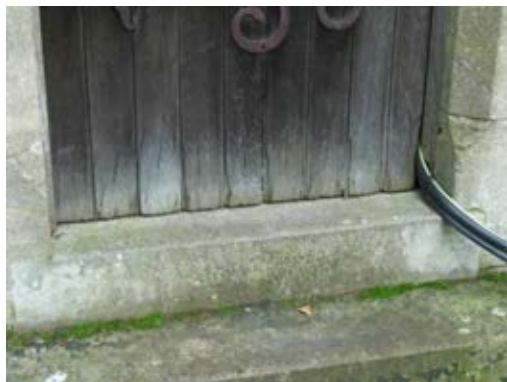
| | 2012 | 2014 | 2017 |
|---|---|---|--|
| 16. | | | |

| | 2012 | 2014 | 2017 |
|---|---|---|--|
| | | Rear right side door deterioration to base and temporary power supply cables. | Rear right side door continues to deteriorate at the base. |

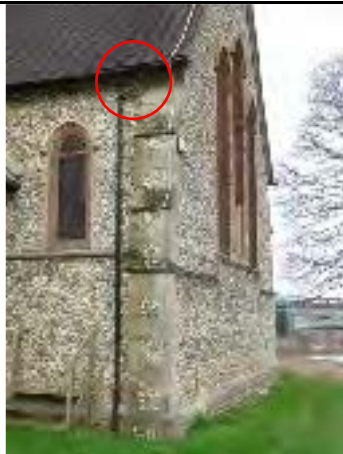
| | 2012 | 2014 | 2017 |
|---|---|--|--|
| 18. | | | |

| | 2012 | 2014 | 2017 |
|---|---|--|--|
| | | Rear right corner damage to stonework on buttress due to dislodged rainwater downpipe. | Rear right corner water staining internally and externally due to dislodged rainwater downpipe. |

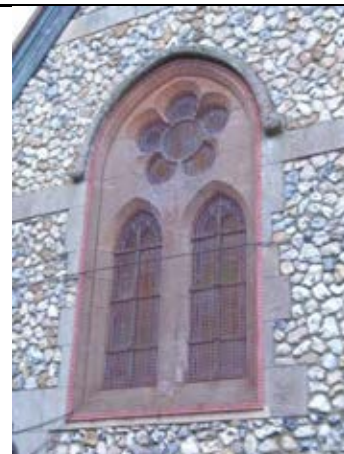
| | 2012 | 2014 | 2017 |
|---|---|---|--|
| 20. | | | |

| | 2012 | 2014 | 2017 |
|---|---|---|--|
| | | | Alter window on East elevation in fair condition. |

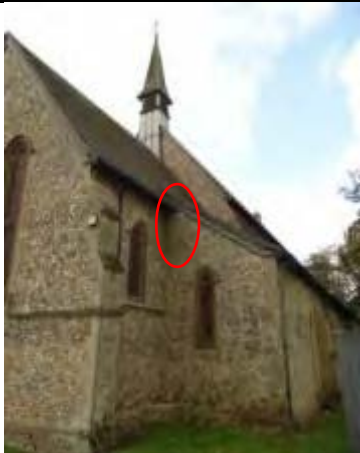
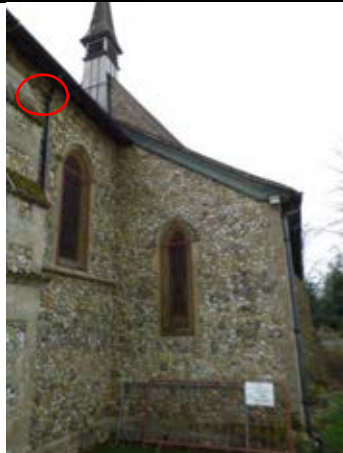
| | 2012 | 2014 | 2017 |
|---|---|--|--|
| 21. | | | |

| | 2012 | 2014 | 2017 |
|---|---|--|--|
| | | Rear left staining to stonework and failed brackets to rainwater downpipe. | Rear left staining to stonework and failed brackets to rainwater downpipe. |

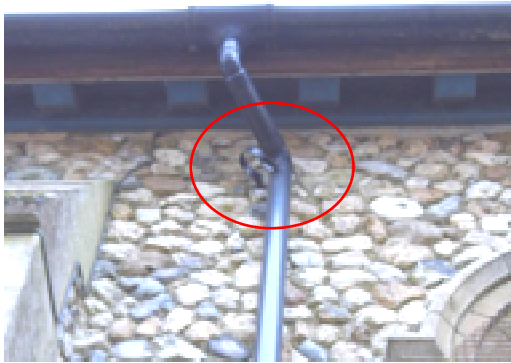
| | 2012 | 2014 | 2017 |
|---|---|--|--|
| 22. | | | |

| | 2012 | 2014 | 2017 |
|---|---|--|--|
| | | | Rear left failed brackets to rainwater downpipe. |

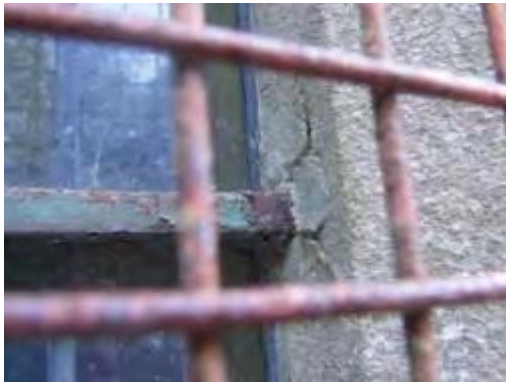
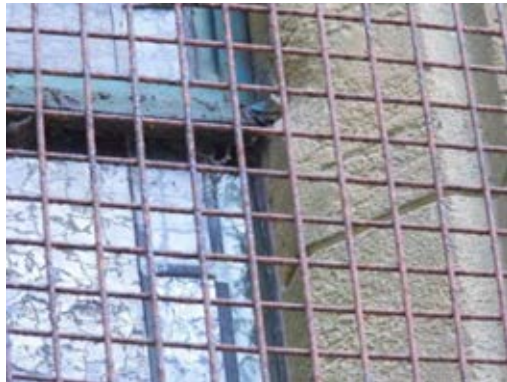
| | 2012 | 2014 | 2017 |
|---|--|--|--|
| 25. | | | |

| | 2012 | 2014 | 2017 |
|---|--|--|--|
| | | Spalling of stonework due to corrosion in steel window supports. | Spalling of stonework due to corrosion in steel window supports. |

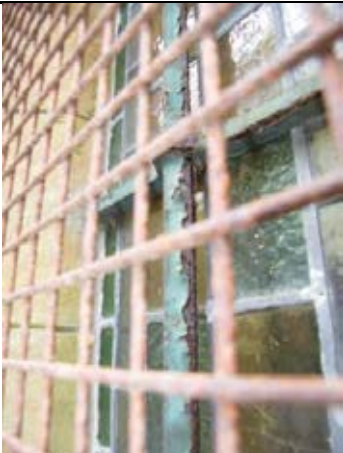
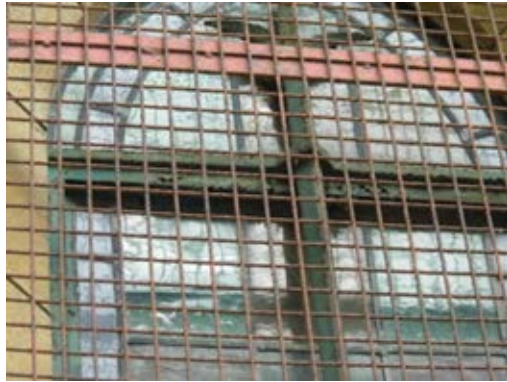
| | 2012 | 2014 | 2017 |
|---|--|--|--|
| 26. | | | |

| | 2012 | 2014 | 2017 |
|---|--|--|--|
| | Corrosion to window supporting steel struts. | | Corrosion to window supporting steel struts. |

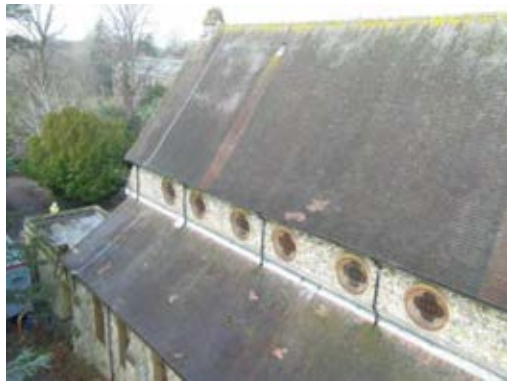
| | 2012 | 2014 | 2017 |
|---|---|---|--|
| 30. | | | |

| | 2012 | 2014 | 2017 |
|---|---|---|--|
| | | | Right side main roof, clerestory and aisle roof.<br>Numerous patch repairs and staining from roof vents. |

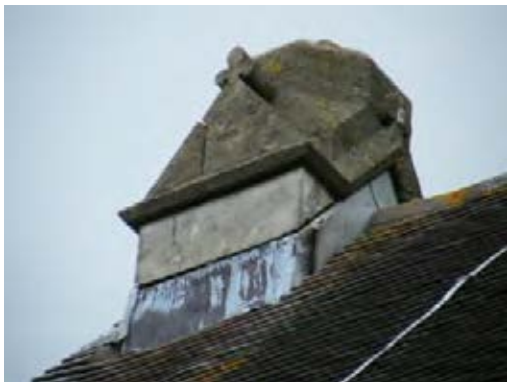
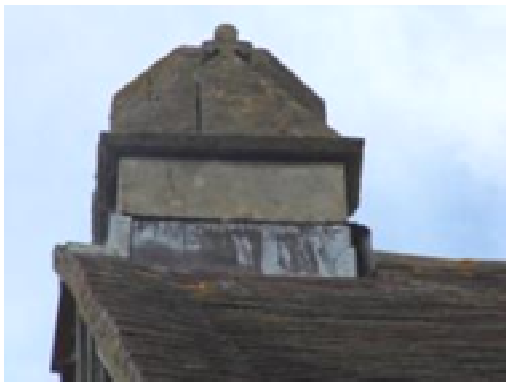
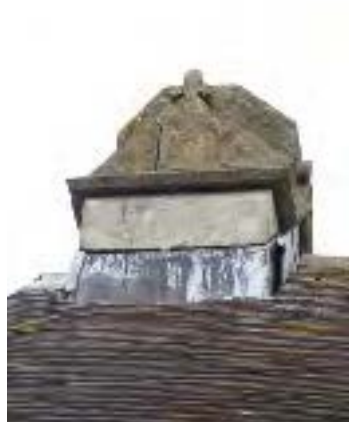
| | 2012 | 2014 | 2017 |
|---|---|--|--|
| 33. | | | |

| | 2012 | 2014 | 2017 |
|---|---|--|--|
| | Front high level flue – cracking to stone and dislodged lead flashings. | Front high level flue – cracking to stone and dislodged lead flashings. | Front high level flue – cracking to stone and dislodged lead flashings. |

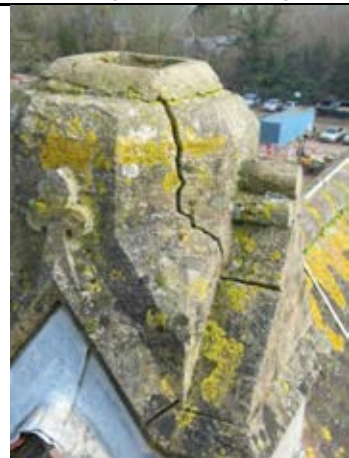
| | 2012 | 2014 | 2017 |
|---|---|--|--|
| 34. | | | |

| | 2012 | 2014 | 2017 |
|---|---|--|--|
| | | | View of crack to front high level flue. |

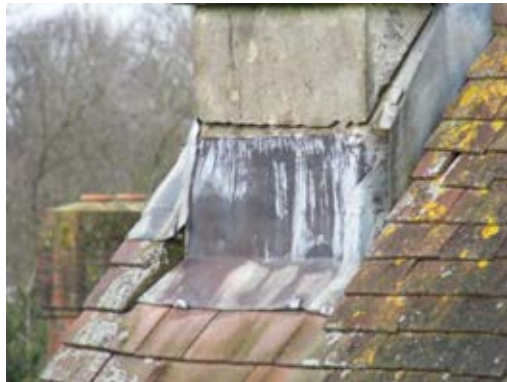
| | 2012 | 2014 | 2017 |
|---|---|---|--|
| 35. | | | <p>View of defective flashings to front high level flue.</p> |

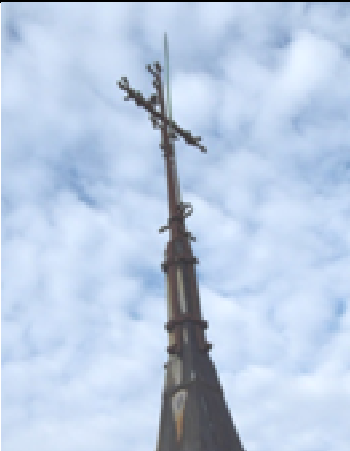
| | 2012 | 2014 | 2017 |
|---|---|---|---|
| 45. | | | |

| | 2012 | 2014 | 2017 |
|---|---|---|---|
| | | | Steel cross to head of spire and lighting conductor earthing rod. Details missing to cross. |

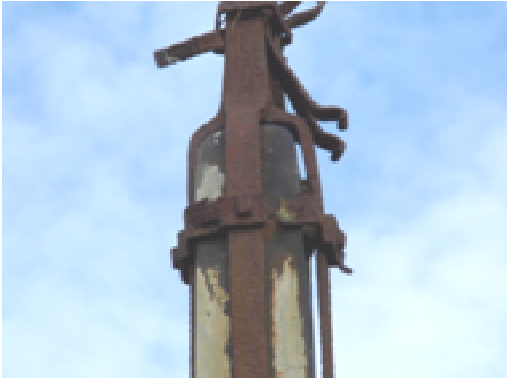
| | 2012 | 2014 | 2017 |
|---|---|---|---|
| 46. | | | |

| | 2012 | 2014 | 2017 |
|---|---|---|---|
| | | | Corrosion and breaks in steel brace fixing the cross to the head of the spire. |

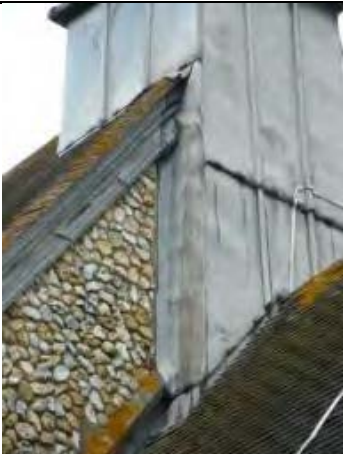
| | 2012 | 2014 | 2017 |
|---|---|--|---|
| 47. | | | |

| | 2012 | 2014 | 2017 |
|---|---|--|---|
| | Lead to rear of bell tower and vertical abutment with flintwork. | Damaged tiling to base of spire on right side of chapel. | Damaged tiling and poor condition of leadwork to base of the spire. |

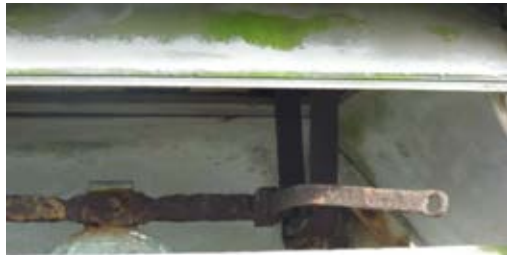
| | 2012 | 2014 | 2017 |
|---|--|---|---|
| 49. | | | |

| | 2012 | 2014 | 2017 |
|---|--|---|---|
| | | | Corrossion to bar supporting the bell in very poor condition. |

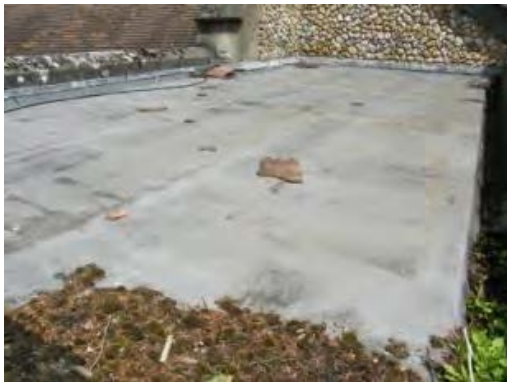
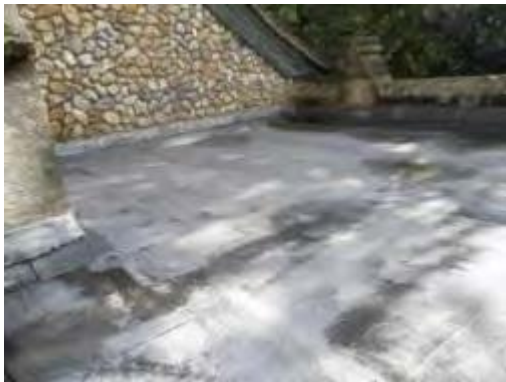
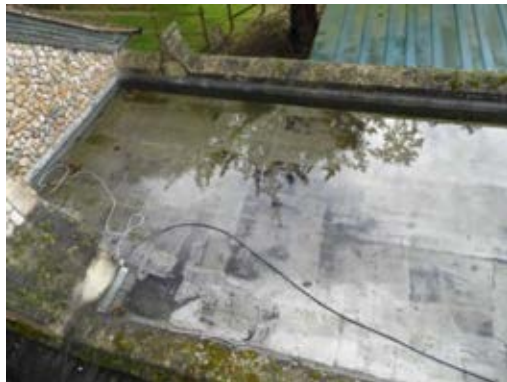
| | 2012 | 2014 | 2017 |
|---|--|---|---|
| 50. | | | |

| | 2012 | 2014 | 2017 |
|---|--|---|---|
| | Flat roof over front right room with worn solar reflective coating and debris. | Front Right Room – Flat roof in fair condition in need of new solar reflective coating. | Front Right Room – Substantial ponding to flat roof is causing damage to finishes internally. |

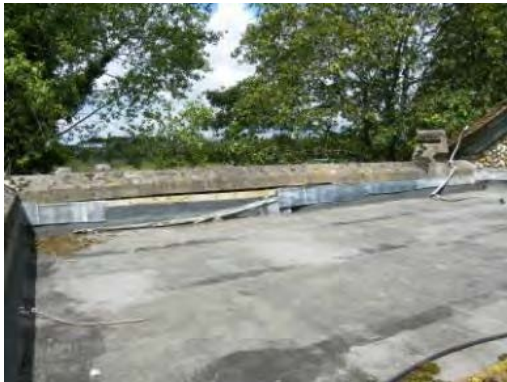
| | 2012 | 2014 | 2017 |
|---|--|--|--|
| 53. | | | |

| | 2012 | 2014 | 2017 |
|---|--|--|--|
| | Front Left Room – Various defects including dislodged lead cover flashing. | | |

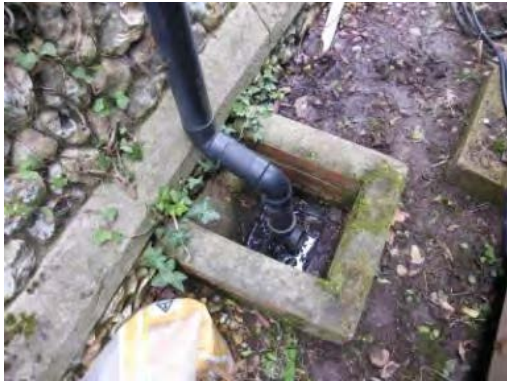
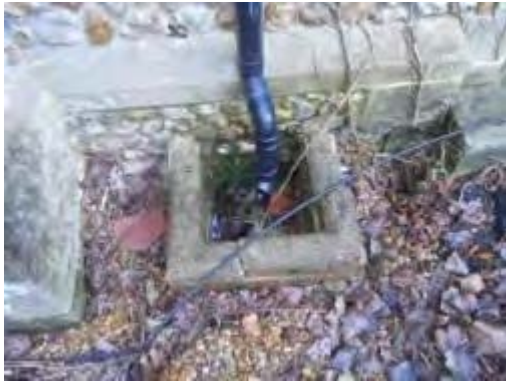
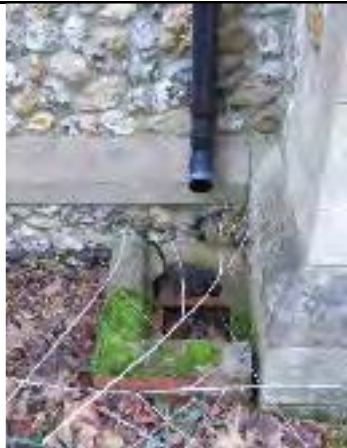
| | 2012 | 2014 | 2017 |
|---|--|--|--|
| 54. | | | |

| | 2012 | 2014 | 2017 |
|---|--|--|--|
| | Typical blocked rainwater gully. | Rainwater Gullies are poor with defective brick upstands and blockages caused by debris. | Rainwater Gullies are poor with defective brick upstands and blockages caused by debris. |

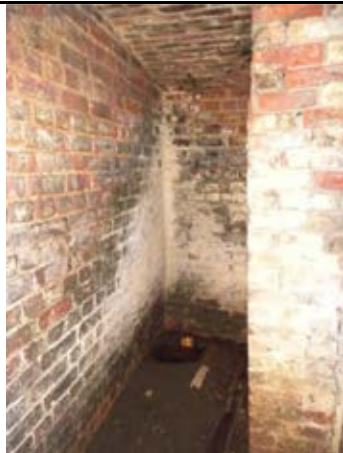
| | 2012 | 2014 | 2017 |
|---|---|---|--|
| 58. | | | |

| | 2012 | 2014 | 2017 |
|---|---|---|--|
| | | | Damp staining to walls. Moisture from boiler may be cause of dry rot to herringbone wood floors above. |

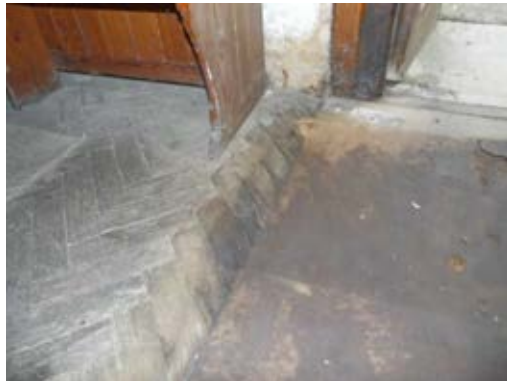
| | 2012 | 2014 | 2017 |
|---|--|--|--|
| 61. | | | |

| | 2012 | 2014 | 2017 |
|---|--|--|--|
| | | | Dampness to floor boarding by entrance is causing wood rot to adjacent wood flooring. |

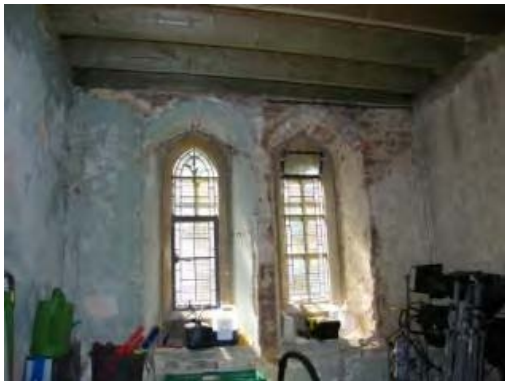
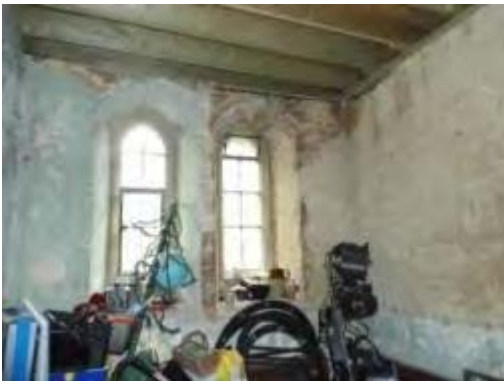
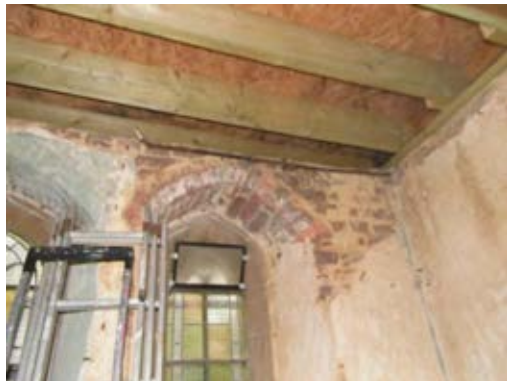
| | 2012 | 2014 | 2017 |
|---|--|--|--|
| 62. | | | |

| | 2012 | 2014 | 2017 |
|---|--|--|--|
| | Front Left Room – deterioration to walls due to water ingress from flat roof. | Front Left Room – Damage to wall plaster due to previous water ingress from flat roof. Damp evident to top right corner. | Front Left Room – Damage to wall plaster due to previous water ingress from flat roof. Damp still evident to top right corner, but to lesser extent. |

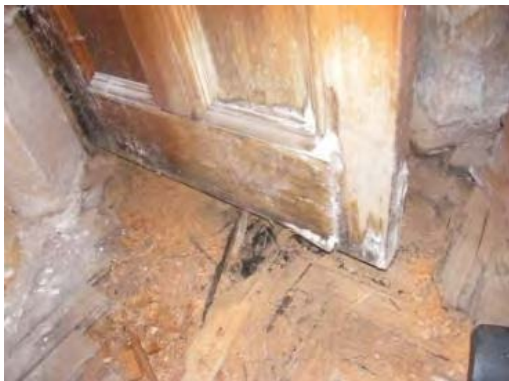
| | 2012 | 2014 | 2017 |
|---|---|---|---|
| 65. | | | |

| | 2012 | 2014 | 2017 |
|---|---|---|---|
| | Door to front left room is rotten and wet rot to parquet wood floor. | | |

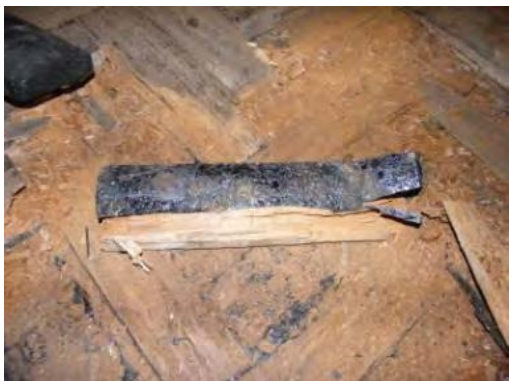
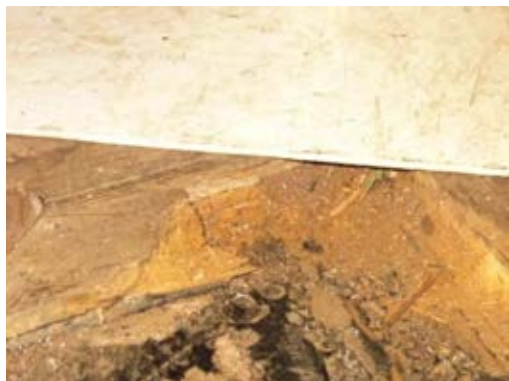
| | 2012 | 2014 | 2017 |
|---|---|---|---|
| 66. | | | |

| | 2012 | 2014 | 2017 |
|---|---|---|---|
| | Close up of wet rot to Front Left Room floor. Parquet wood floor tiles have bitumen adhesive (may contain asbestos) | | Close up of potential dry rot to Front Left Room floor. Possible asbestos contained within bitumen flooring adhesive. |

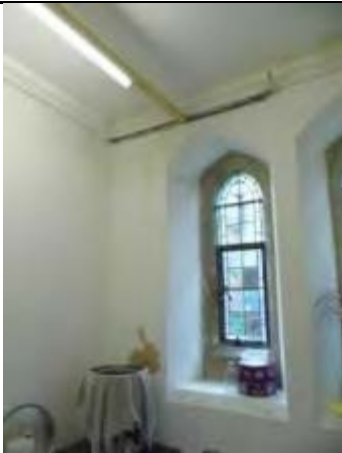
| | 2012 | 2014 | 2017 |
|---|--|---|---|
| 68. | | | |

| | 2012 | 2014 | 2017 |
|---|--|---|---|
| | Front Right Room – Temporary kitchen. | Front Right Room – Dampness to front wall. | Front Right Room – Extensive dampness to front right wall needs urgent attention. |

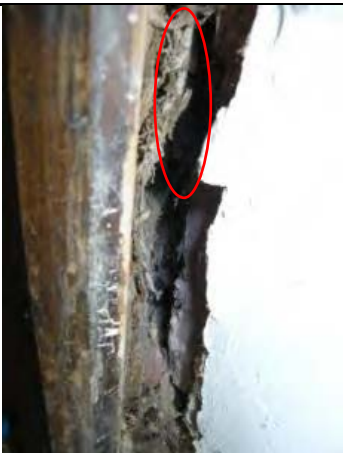
| | 2012 | 2014 | 2017 |
|---|--|---|--|
| 69. | | | |

| | 2012 | 2014 | 2017 |
|---|--|---|--|
| | Front Right Room – possible dry rot hyphae within door frame. | | Front Right Room – Wood rot to timber floors around perimeter where against damp external walls. |

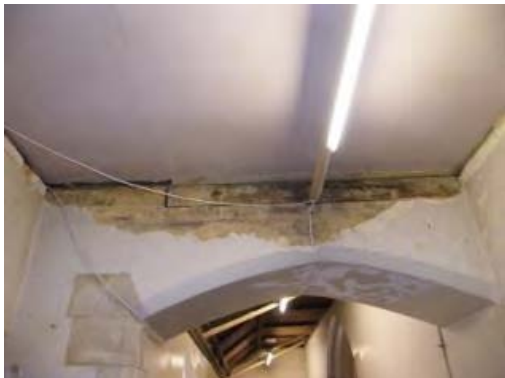
| | 2012 | 2014 | 2017 |
|---|--|---|--|
| 70. | | | |

| | 2012 | 2014 | 2017 |
|---|--|---|--|
| | Front Right Lobby – damage to wall plaster due to previous water ingress from flat roof. | Front Right Lobby – Dampness around door into front right room. | Front Right Lobby – Dampness around door into front right room. |

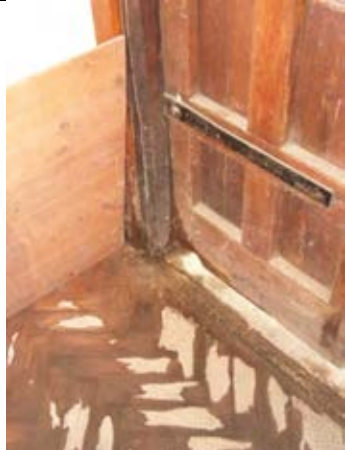
| | 2012 | 2014 | 2017 |
|---|---|---|--|
| 72. | | | |

| | 2012 | 2014 | 2017 |
|---|---|---|--|
| | | | Front Right Lobby – Extensive water penetration around base of door will cause damage to wood floor. |

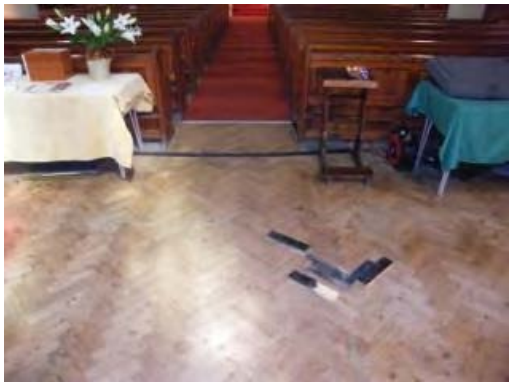
| | 2012 | 2014 | 2017 |
|---|--|--|---|
| 74. | | | |

| | 2012 | 2014 | 2017 |
|---|--|--|---|
| | Lifting parquet wood flooring due to leakage from roof vents at high level. | | |

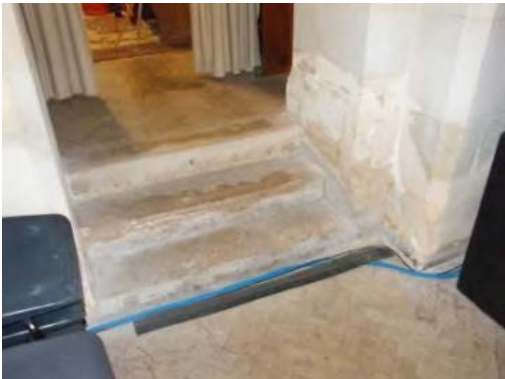
| | 2012 | 2014 | 2017 |
|---|---|--|--|
| 82. | | | |

| | 2012 | 2014 | 2017 |
|---|---|--|--|
| | Aisle side stone steps on both side are in poor condition. | | |

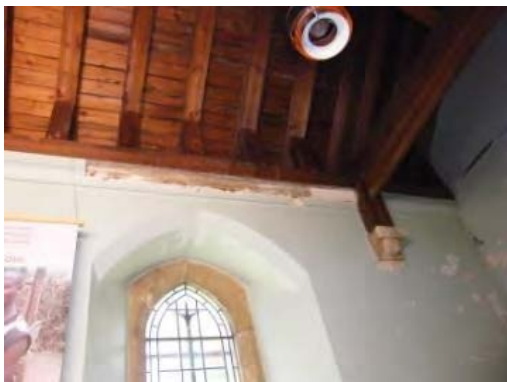
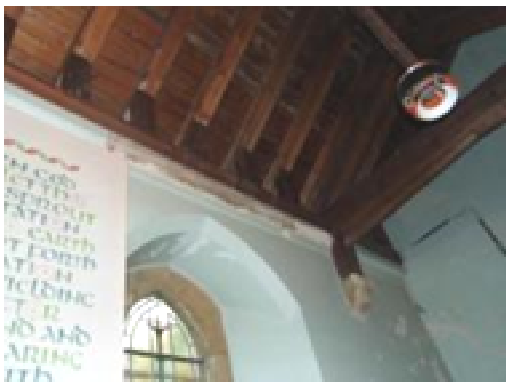
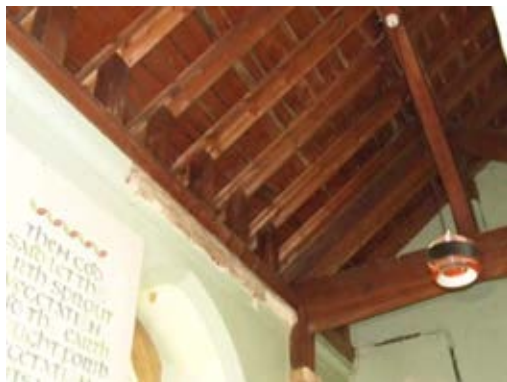
| | 2012 | 2014 | 2017 |
|---|--|---|---|
| 88. | | | |

| | 2012 | 2014 | 2017 |
|---|--|---|---|
| | Front right aisle – damage to plaster coving from water ingress. | Front right aisle – Extensive water damage to wall plaster, coving and underside of timber roof boarding. | Front right aisle – Extensive water damage to wall plaster, coving and underside of timber roof boarding. |

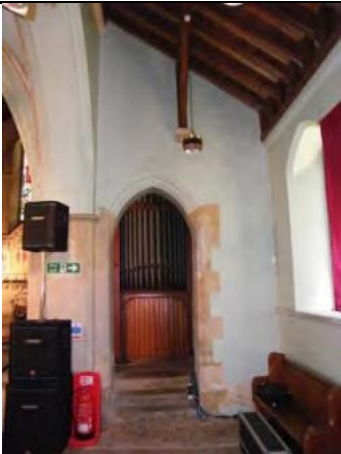
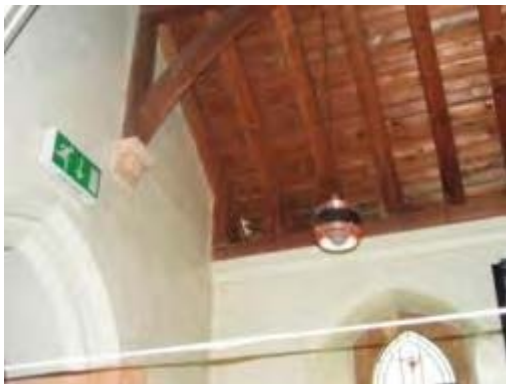
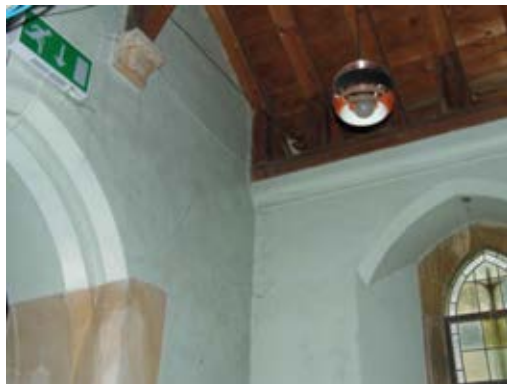
| | 2012 | 2014 | 2017 |
|---|---|---|--|
| 89. | | | |

| | 2012 | 2014 | 2017 |
|---|---|---|--|
| | Rear right aisle – view towards steps leading up to the rear right fire exit. | Rear right aisle – Water staining to roof timbers in bottom corner. | Rear right aisle – Water staining to roof timbers in bottom corner. |

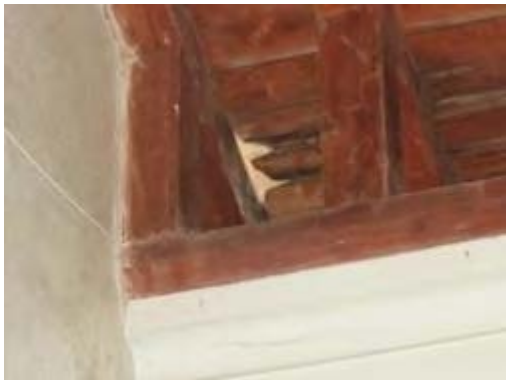
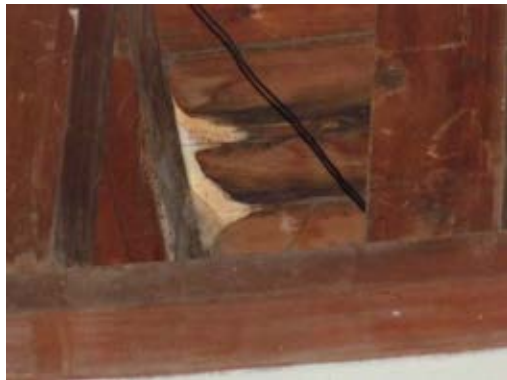
| | 2012 | 2014 | 2017 |
|---|---|---|--|
| 90. | | | |

| | 2012 | 2014 | 2017 |
|---|---|---|--|
| | | Rear right aisle - Staining to roof timbers. | Rear right aisle - Staining to roof timbers. |

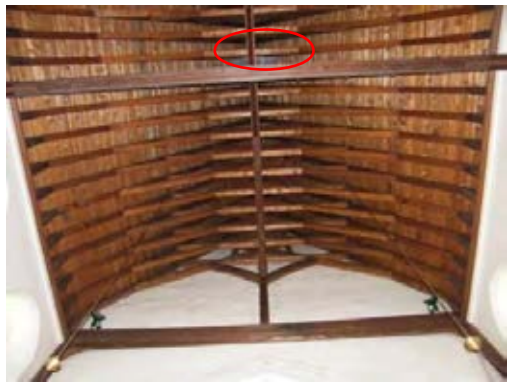
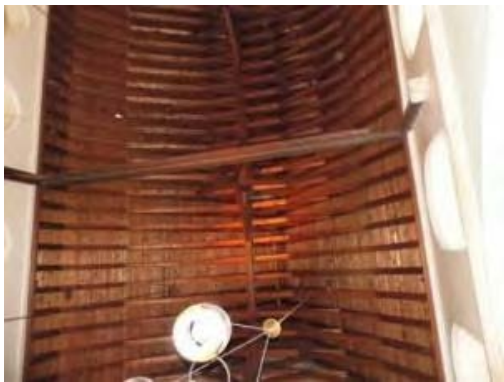
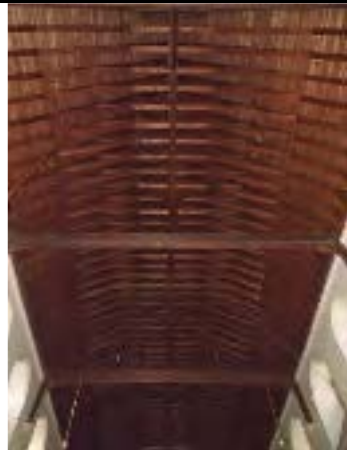
| | 2012 | 2014 | 2017 |
|---|--|---|--|
| 94. | | | |

| | 2012 | 2014 | 2017 |
|---|--|---|--|
| | View of main roof structure to the knave. Towards the top of the photograph you can see the duct linked to the external vents. | Main roof structure viewed from altar (at bottom) towards the entrance (at top). | Main roof structure with localised areas of minor staining to timber boarding. |

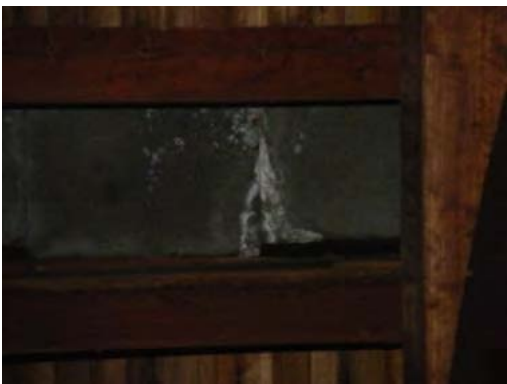
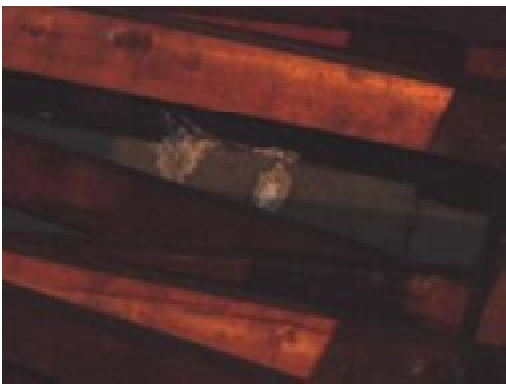
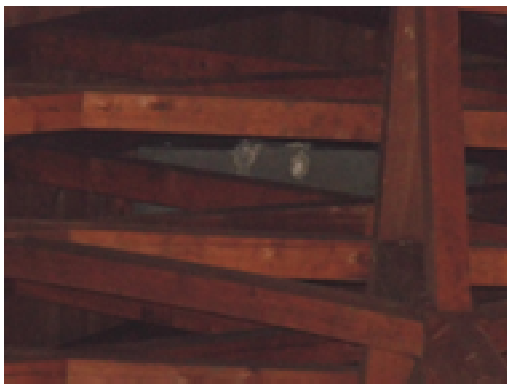
| | 2012 | 2014 | 2017 |
|---|--|---|--|
| 96. | | | |

| | 2012 | 2014 | 2017 |
|---|--|---|--|
| | Indication of where water leakage is occurring to the roof vent ducts. | Water staining to underside of vents at high level in main roof. | Water staining to underside of vents at high level in main roof. |

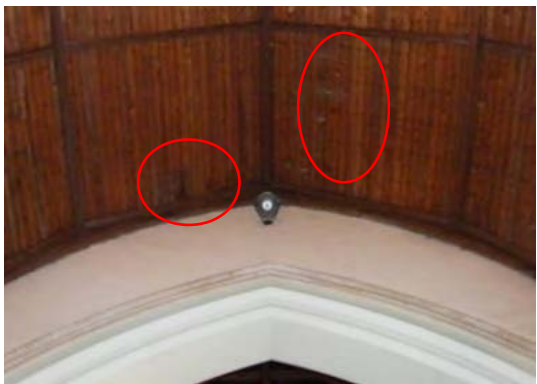
| | 2012 | 2014 | 2017 |
|---|--|---|---|
| 100. | | | |

| | 2012 | 2014 | 2017 |
|---|--|---|---|
| | Water staining to underside of chancery roof in area beneath the bell tower. | | |
