Photographs 2012-2017

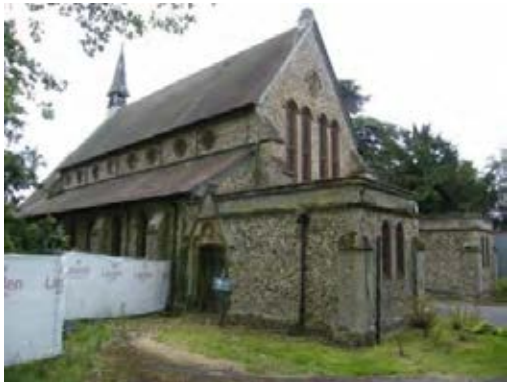
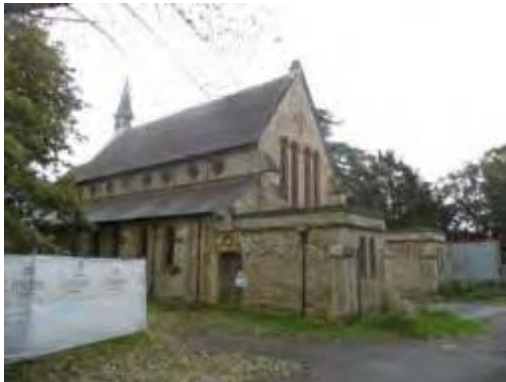
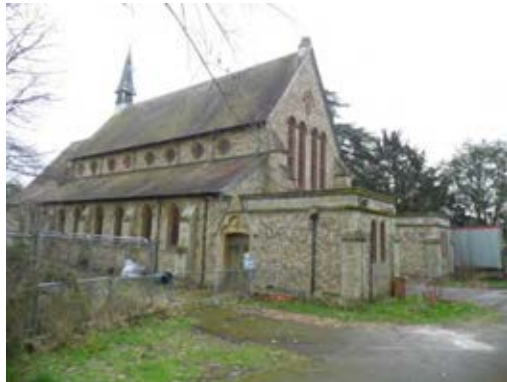
| | 2012 | 2014 | 2017 |
|---|---|--|--|
| 5. | | | |

| | 2012 | 2014 | 2017 |
|---|---|--|--|
| | Left Elevation (North) | Left Elevation (North) | Left Elevation (North) |

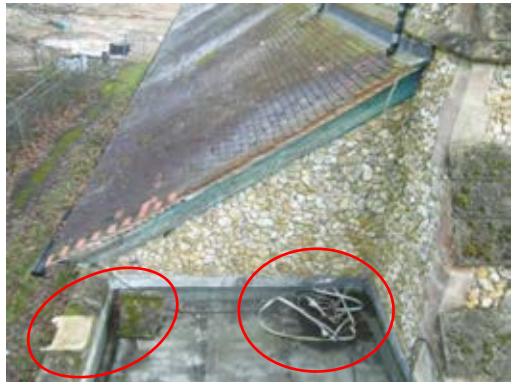
| | 2012 | 2014 | 2017 |
|---|---|---|--|
| 7. | | | |

| | 2012 | 2014 | 2017 |
|---|---|---|--|
| | | | Front left flat roof – Dislodged key stone sitting on roof. Detached lightning conductor left on roof. |

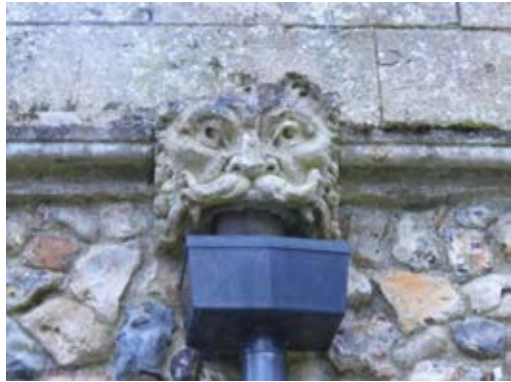
| | 2012 | 2014 | 2017 |
|---|---|---|--|
| 8. | | | |

| | 2012 | 2014 | 2017 |
|---|---|---|--|
| | | | Front left flat roof rainwater outlet - stone feature. |

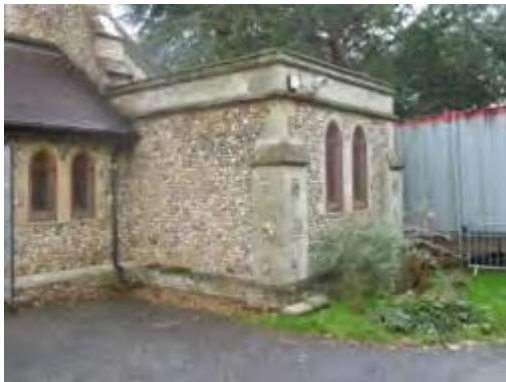
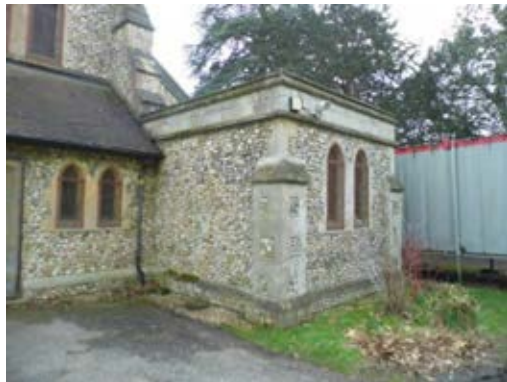
| | 2012 | 2014 | 2017 |
|---|---|---|--|
| 12. | | | |

| | 2012 | 2014 | 2017 |
|---|---|---|--|
| | | Front Right. | Front Right. |

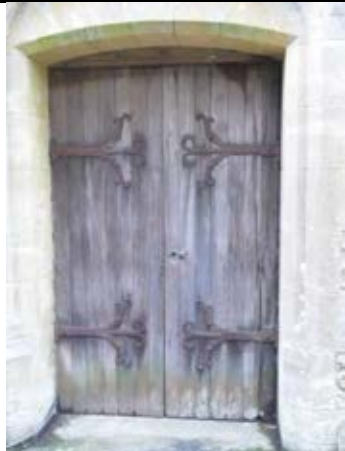
| | 2012 | 2014 | 2017 |
|---|---|---|--|
| 13. | | | |

| | 2012 | 2014 | 2017 |
|---|---|---|--|
| | | | Side Right Doors – Wet patch to top and bottom right, so may be due to water from flat roof above e. |

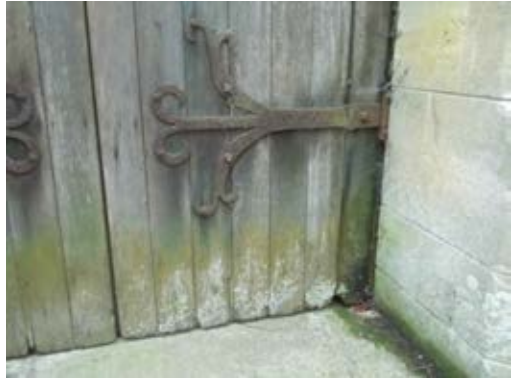
| | 2012 | 2014 | 2017 |
|---|---|---|--|
| 14. | | | |

| | 2012 | 2014 | 2017 |
|---|---|---|--|
| | | | Side Right Doors – Bottom Right corresponds with water penetration to lobby floor internally. |

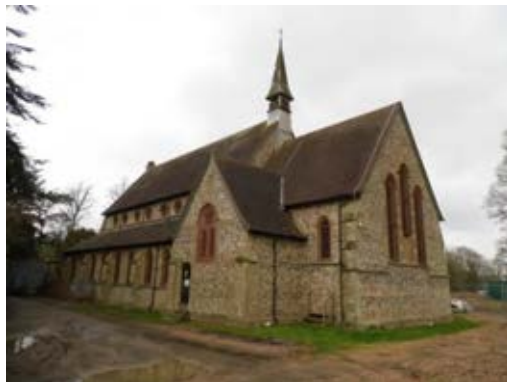
| | 2012 | 2014 | 2017 |
|---|---|---|--|
| 15. | | | |

| | 2012 | 2014 | 2017 |
|---|---|---|--|
| | Rear & Right Elevation (East & South) | Rear & Right Elevation (East & South) | Rear & Right Elevation (East & South) |

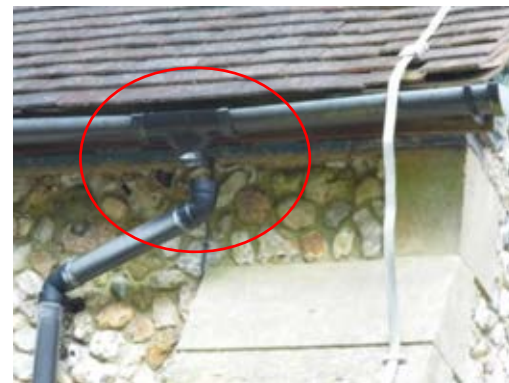
| | 2012 | 2014 | 2017 |
|---|---|---|--|
| 19. | | | |

| | 2012 | 2014 | 2017 |
|---|---|---|--|
| | | | Rear right corner – dislodged rainwater downpipe joint. |

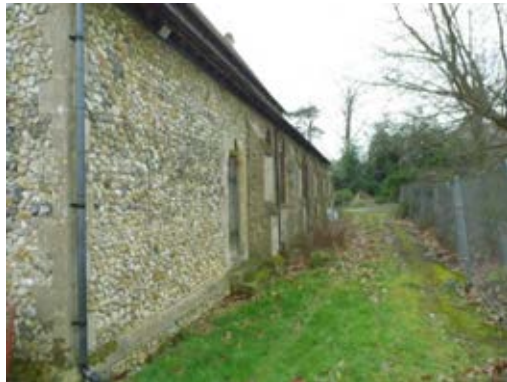
| | 2012 | 2014 | 2017 |
|---|--|---|--|
| 23. | | | |

| | 2012 | 2014 | 2017 |
|---|--|---|--|
| | | | Left Side Elevation (North) looking towards front. |

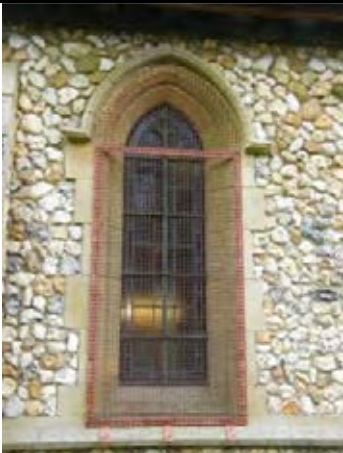
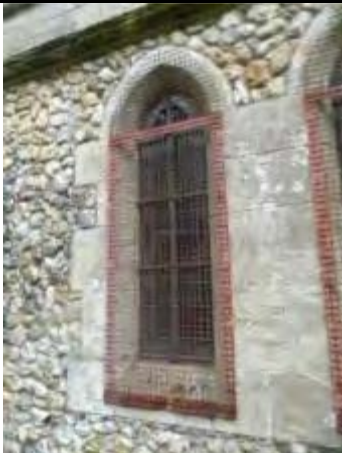
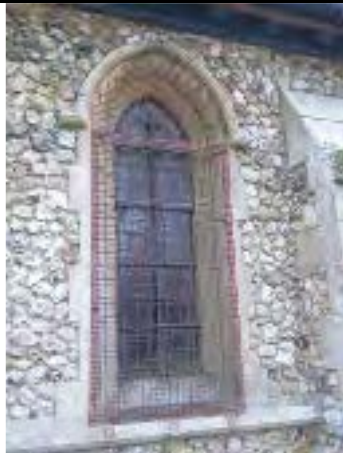
| | 2012 | 2014 | 2017 |
|---|--|---|--|
| 24. | | | |

| | 2012 | 2014 | 2017 |
|---|--|---|--|
| | Typical window with steel support, leaded light unit and stone surround. | Typical window with steel support, leaded light unit and stone surround. | Typical window with steel support, leaded light unit and stone surround. |

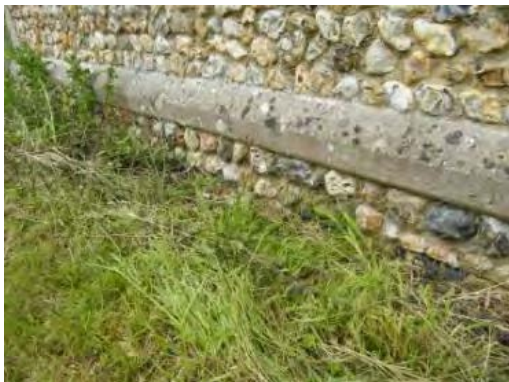
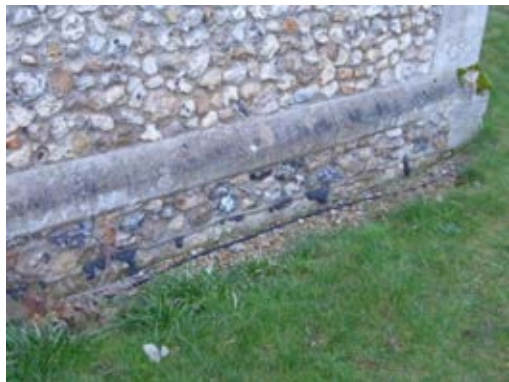
| | 2012 | 2014 | 2017 |
|---|--|---|--|
| 27. | | | |

| | 2012 | 2014 | 2017 |
|---|--|---|--|
| | Bitumen type damp proof course (dpc) | | Bitumen type damp proof course (dpc) may potentially be ineffective. |

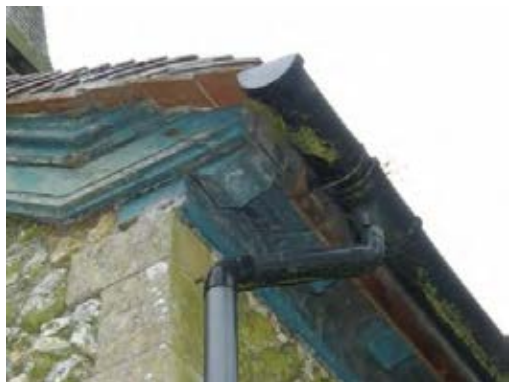
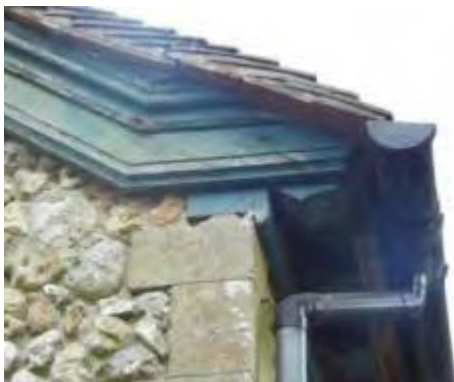
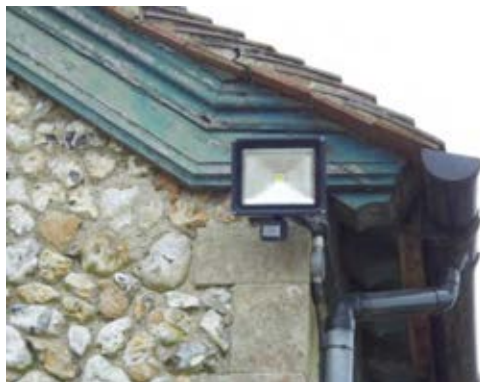
| | 2012 | 2014 | 2017 |
|---|--|---|--|
| 28. | | | |

| | 2012 | 2014 | 2017 |
|---|--|---|--|
| | Overdue decoration to external joinery. | Overdue decoration to external joinery. | Overdue decoration to external joinery. New LED external lighting installed. |

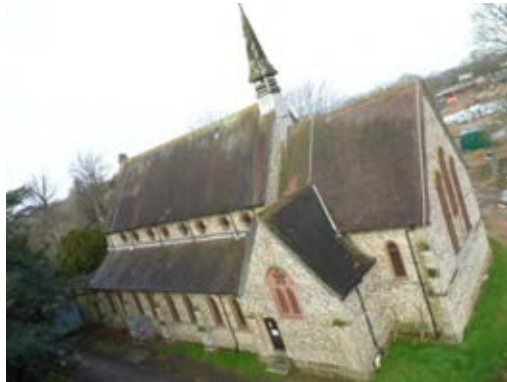
| | 2012 | 2014 | 2017 |
|---|---|---|--|
| 29. | | | |

| | 2012 | 2014 | 2017 |
|---|---|---|--|
| | | | Rear & Right Elevation (East & South) from above. |

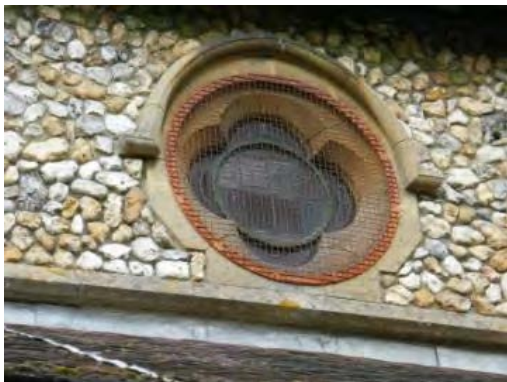
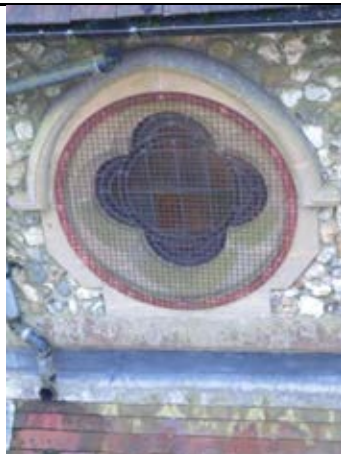
| | 2012 | 2014 | 2017 |
|---|---|---|--|
| 31. | | | |

| | 2012 | 2014 | 2017 |
|---|---|---|--|
| | Typical oculus window. | | Typical oculus window to clerestory. |

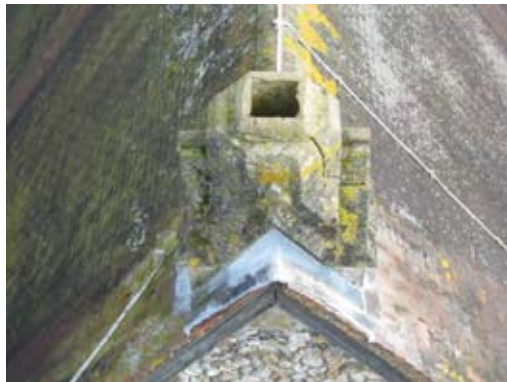
| | 2012 | 2014 | 2017 |
|---|---|---|--|
| 32. | | | |

| | 2012 | 2014 | 2017 |
|---|---|---|--|
| | | | Front high level flue viewed from above. |

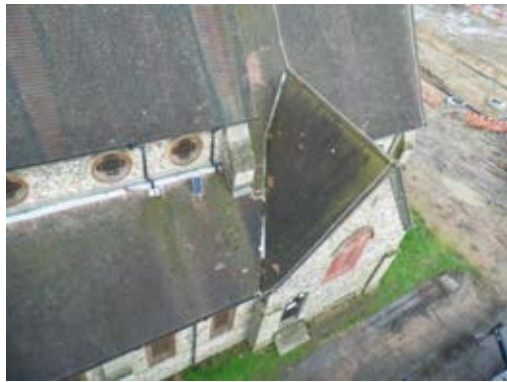
| | 2012 | 2014 | 2017 |
|---|---|---|--|
| 36. | | | <p>Rear right roofs viewed from above.</p> |

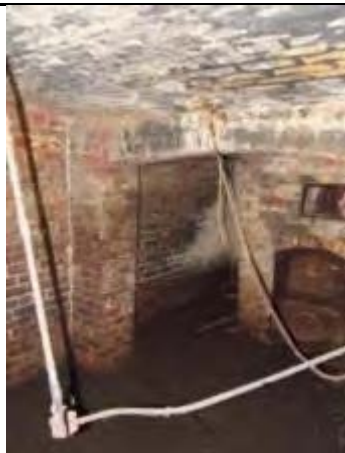
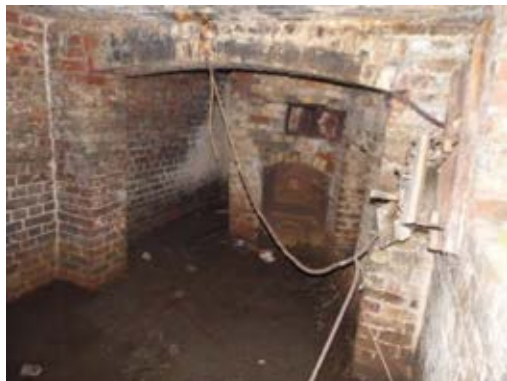
| | 2012 | 2014 | 2017 |
|---|---|---|--|
| 57. | | | |

| | 2012 | 2014 | 2017 |
|---|---|---|--|
| | | Basement Room – Dampness to walls and ceiling, with thick wet silt debris to floor. | Basement Room – Dampness to walls and ceiling, with thick wet silt debris to floor. |

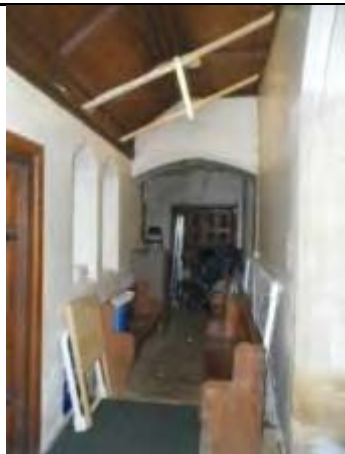
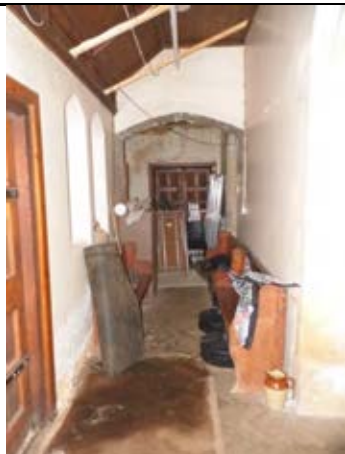
| | 2012 | 2014 | 2017 |
|---|--|--|---|
| 59. | | | |

| | 2012 | 2014 | 2017 |
|---|--|--|---|
| | | Main Entrance – Viewed towards front left room. | Main Entrance – Viewed towards front left room. |

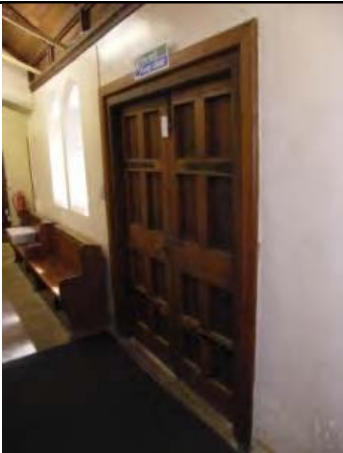
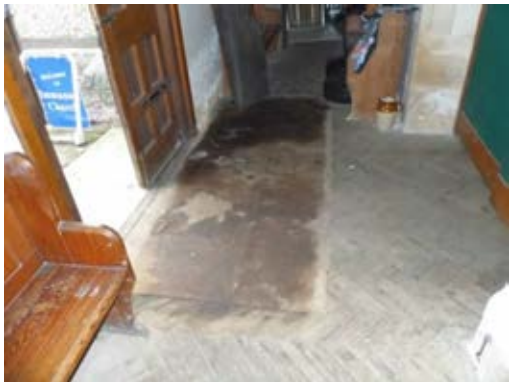
| | 2012 | 2014 | 2017 |
|---|--|--|---|
| 60. | | | |

| | 2012 | 2014 | 2017 |
|---|--|--|---|
| | Internal side of main entrance doors. | | Extensive dampness to boarded floor in entrance, most likely due to water penetrating under door. |

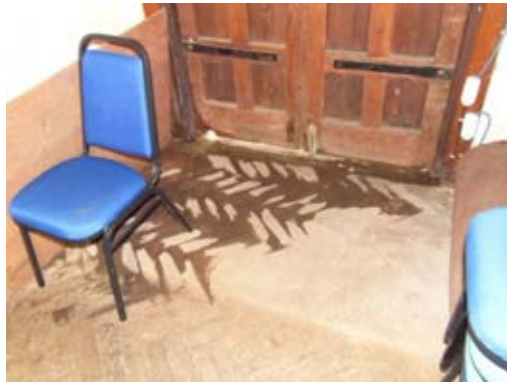
| | 2012 | 2014 | 2017 |
|---|---|---|--|
| 71. | | | |

| | 2012 | 2014 | 2017 |
|---|---|---|--|
| | | | Front Right Lobby – Water penetration around door, which may be coming from flat roof above. |

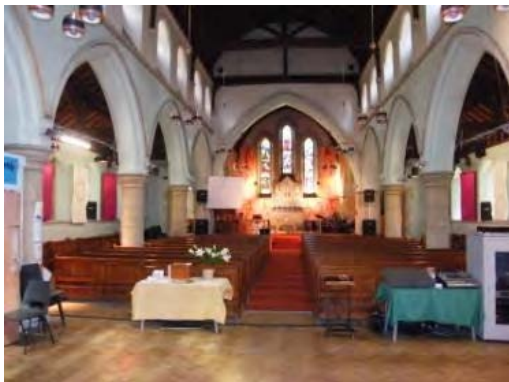
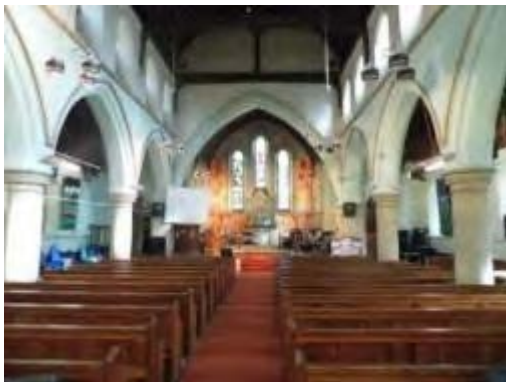
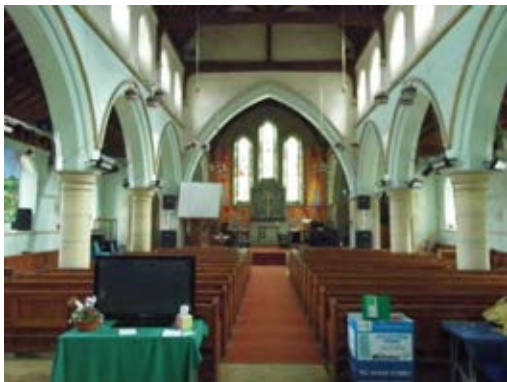
| | 2012 | 2014 | 2017 |
|---|--|--|---|
| 73. | | | |

| | 2012 | 2014 | 2017 |
|---|--|--|---|
| | View down nave from entrance towards the altar, with aisles to the sides. | View from Nave towards Altar. | View down nave from entrance towards the altar, with aisles to the sides. |

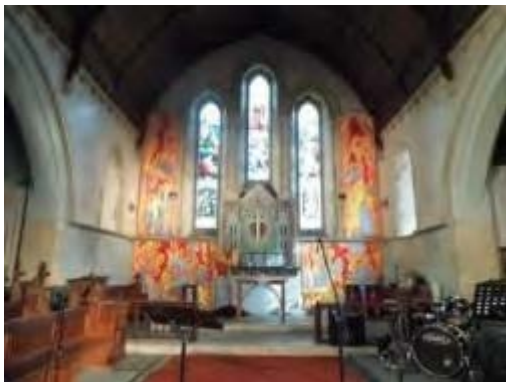
| | 2012 | 2014 | 2017 |
|---|---|---|---|
| 79. | | | |

| | 2012 | 2014 | 2017 |
|---|---|---|---|
| | View from the end of the nave towards the altar. | View from nave to altar. | View from nave to altar and left chancel. |

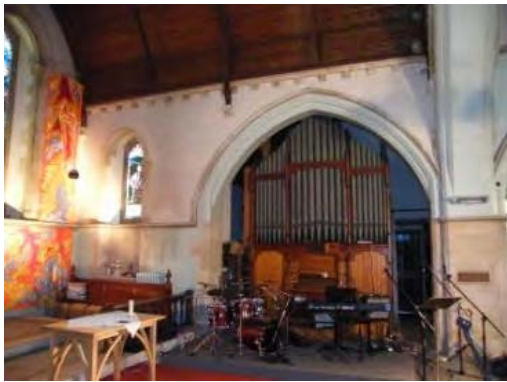
| | 2012 | 2014 | 2017 |
|---|---|---|---|
| 80. | | | |

| | 2012 | 2014 | 2017 |
|---|---|---|---|
| | Chancel – right side towards organ. To left of organ is the original electric intake. | View from altar towards organ in right chancel. | Chancel – right side towards organ. To left of organ is the original electric intake. |

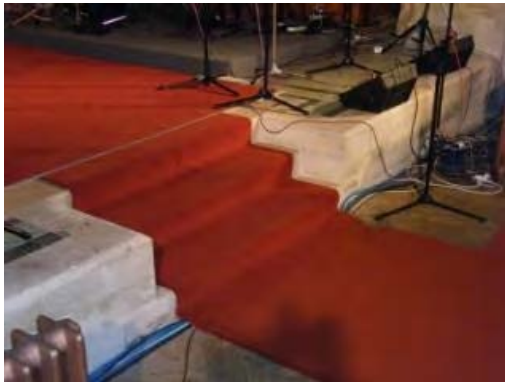
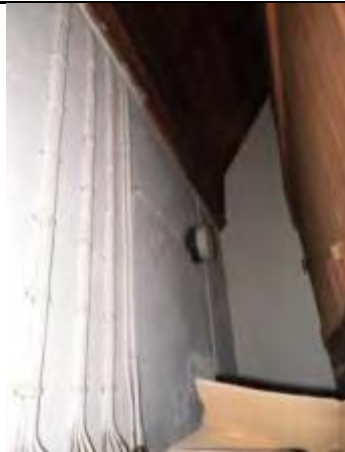
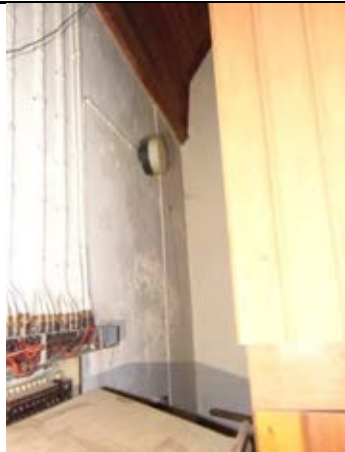
| | 2012 | 2014 | 2017 |
|---|---|--|--|
| 81. | | | |

| | 2012 | 2014 | 2017 |
|---|---|--|--|
| | Chancel is raised above nave and there is a potential risk of falling due to unguarded edge | Dampness to rear external wall behind organ, due to faulty rainwater goods. | Dampness to rear external wall behind organ, due to previously faulty rainwater goods. |

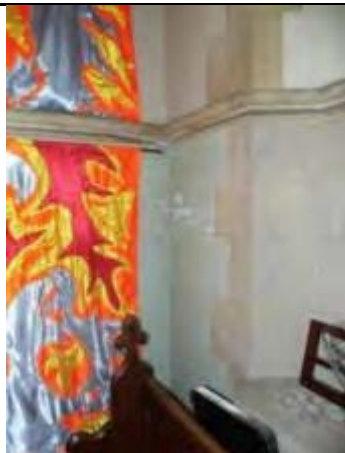
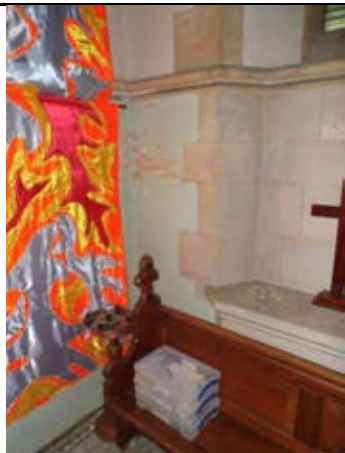
| | 2012 | 2014 | 2017 |
|---|--|--|--|
| 85. | | | |

| | 2012 | 2014 | 2017 |
|---|--|--|--|
| | | Alter – Dampness to wall in rear right corner, due to faulty rainwater goods. | Alter – Ongoing dampness to wall in rear right corner, due to faulty rainwater goods identified during our survey in 2012. |

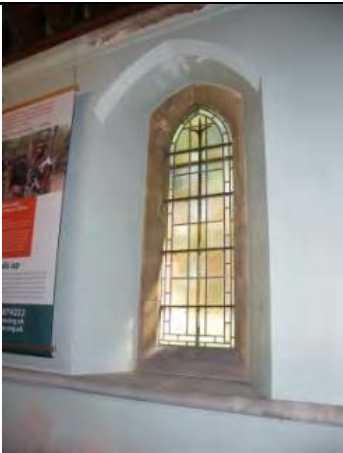
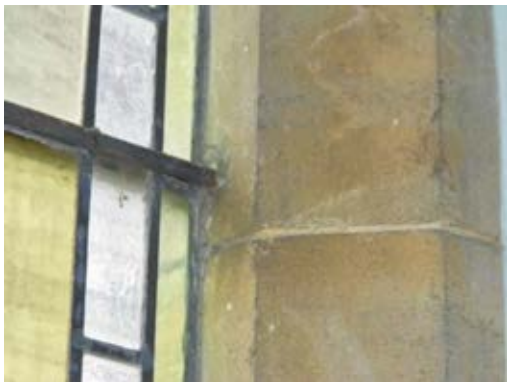
| | 2012 | 2014 | 2017 |
|---|--|--|--|
| 86. | | | |

| | 2012 | 2014 | 2017 |
|---|--|--|--|
| | Typical window. | | Typical window connection to stone surround. |

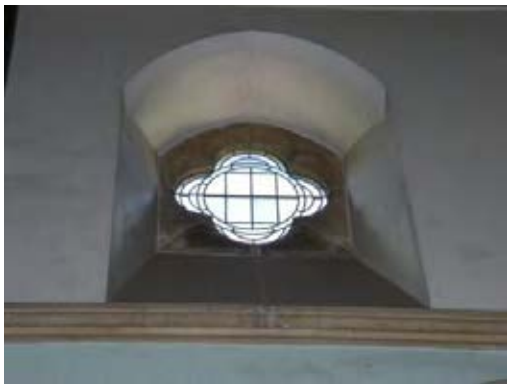
| | 2012 | 2014 | 2017 |
|---|--|---|---|
| 87. | | | |

| | 2012 | 2014 | 2017 |
|---|--|---|---|
| | Typical oculus window to clerestory. | | |

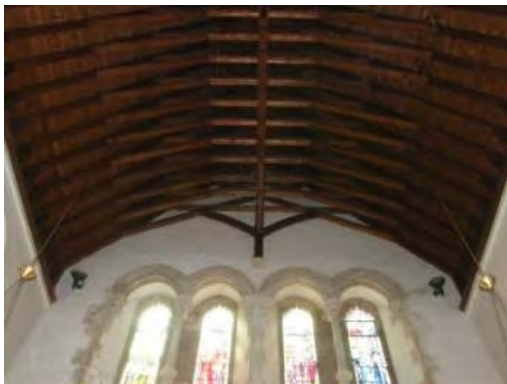
| | 2012 | 2014 | 2017 |
|---|--|---|--|
| 93. | | | |

| | 2012 | 2014 | 2017 |
|---|--|---|--|
| | Roof structure at abutment with front wall. | | |

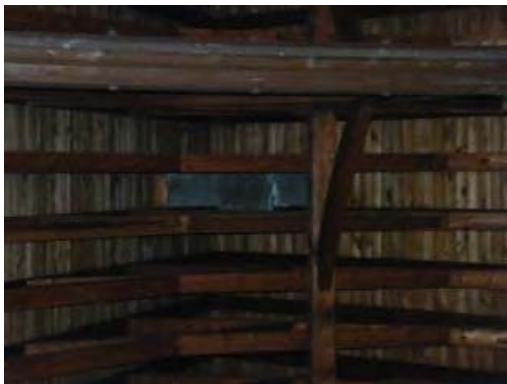
| | 2012 | 2014 | 2017 |
|---|--|---|--|
| 95. | | | |

| | 2012 | 2014 | 2017 |
|---|--|---|--|
| | View of one of the ducts linked to the external roof vents. | | |

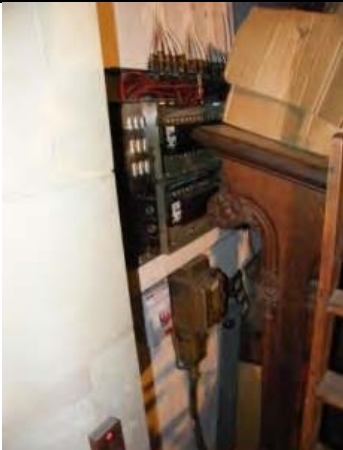
| | 2012 | 2014 | 2017 |
|---|---|---|---|
| 101. | | | |

| | 2012 | 2014 | 2017 |
|---|---|---|---|
| | Redundant original electric intake and distribution board behind organ in chancel. | | |

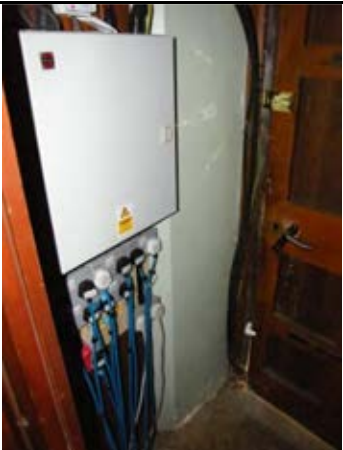
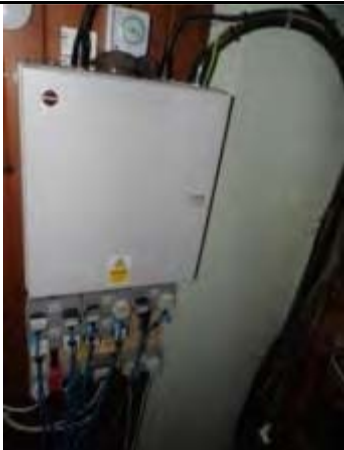
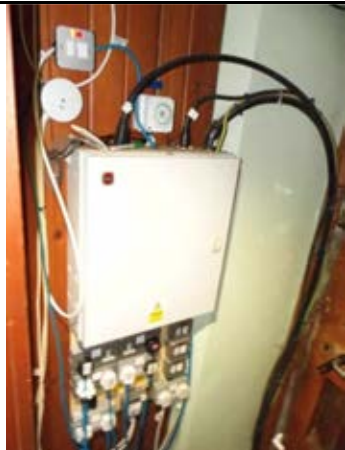
| | 2012 | 2014 | 2017 |
|---|---|---|---|
| 102. | | | |

| | 2012 | 2014 | 2017 |
|---|---|---|---|
| | New temporary power supply (enters at base of door) and distribution board, linked to double sockets, and then extension leads. | Temporary electrical supply and distribution board, with plug based circuits. | New temporary power supply and distribution board, linked to double sockets beneath, and then onto extension leads throughout the Chapel. |
